Andean Community Reduces Erosion in Disturbed Cloud Forests

Laura Backus¹, Enma Sacatoro ², John Giordanengo³

Summary

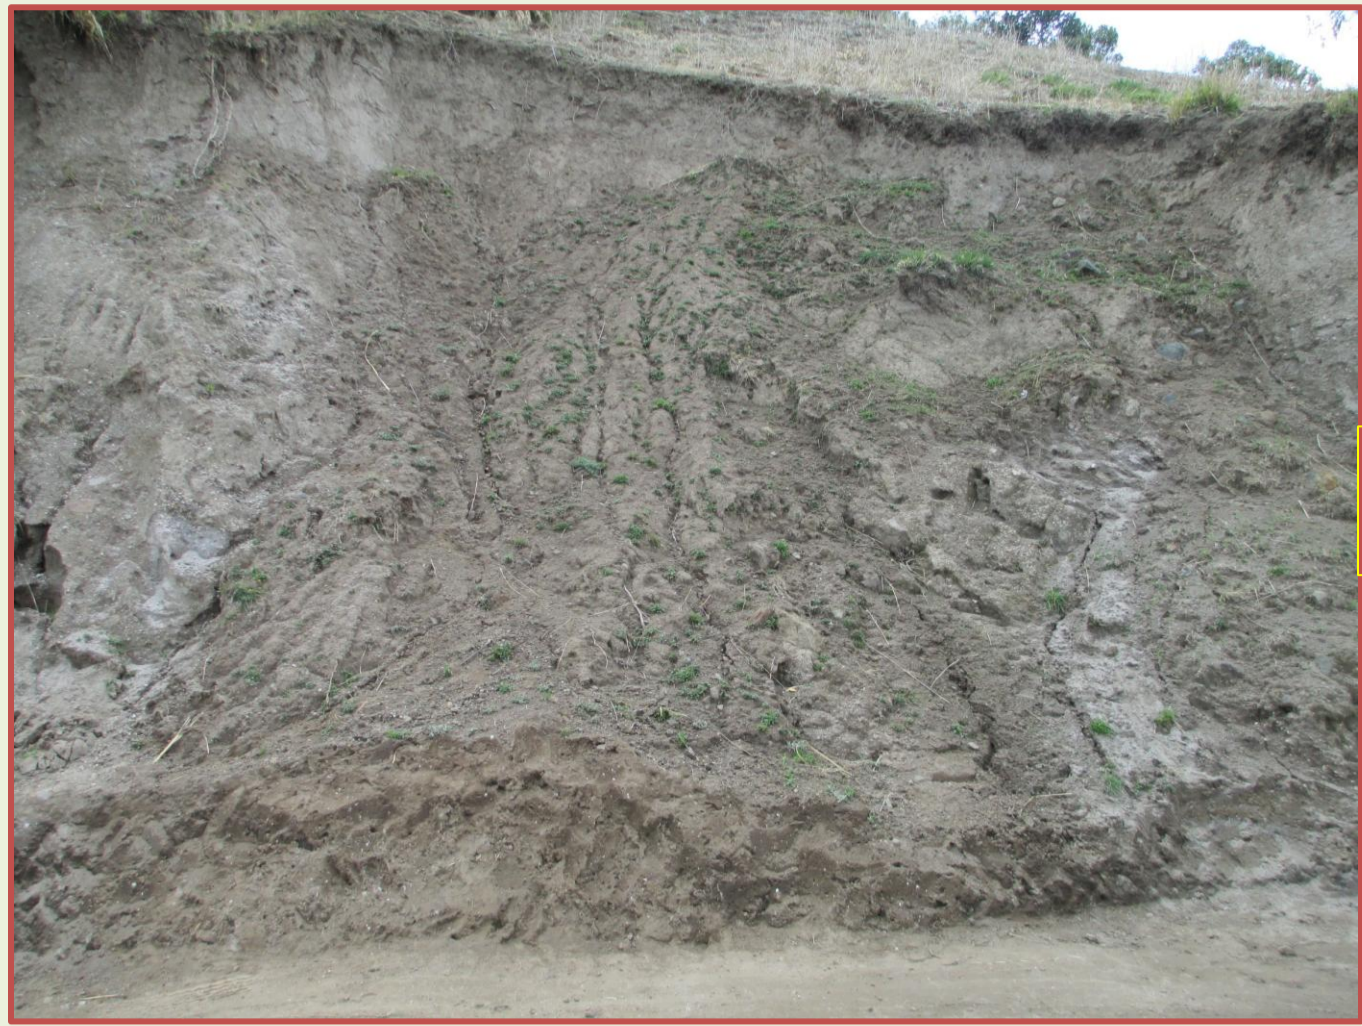
2012 - Chimbusig road cut, pre-project. Slumping of “tierra blanca” volcanic subsoils was causing road closures.

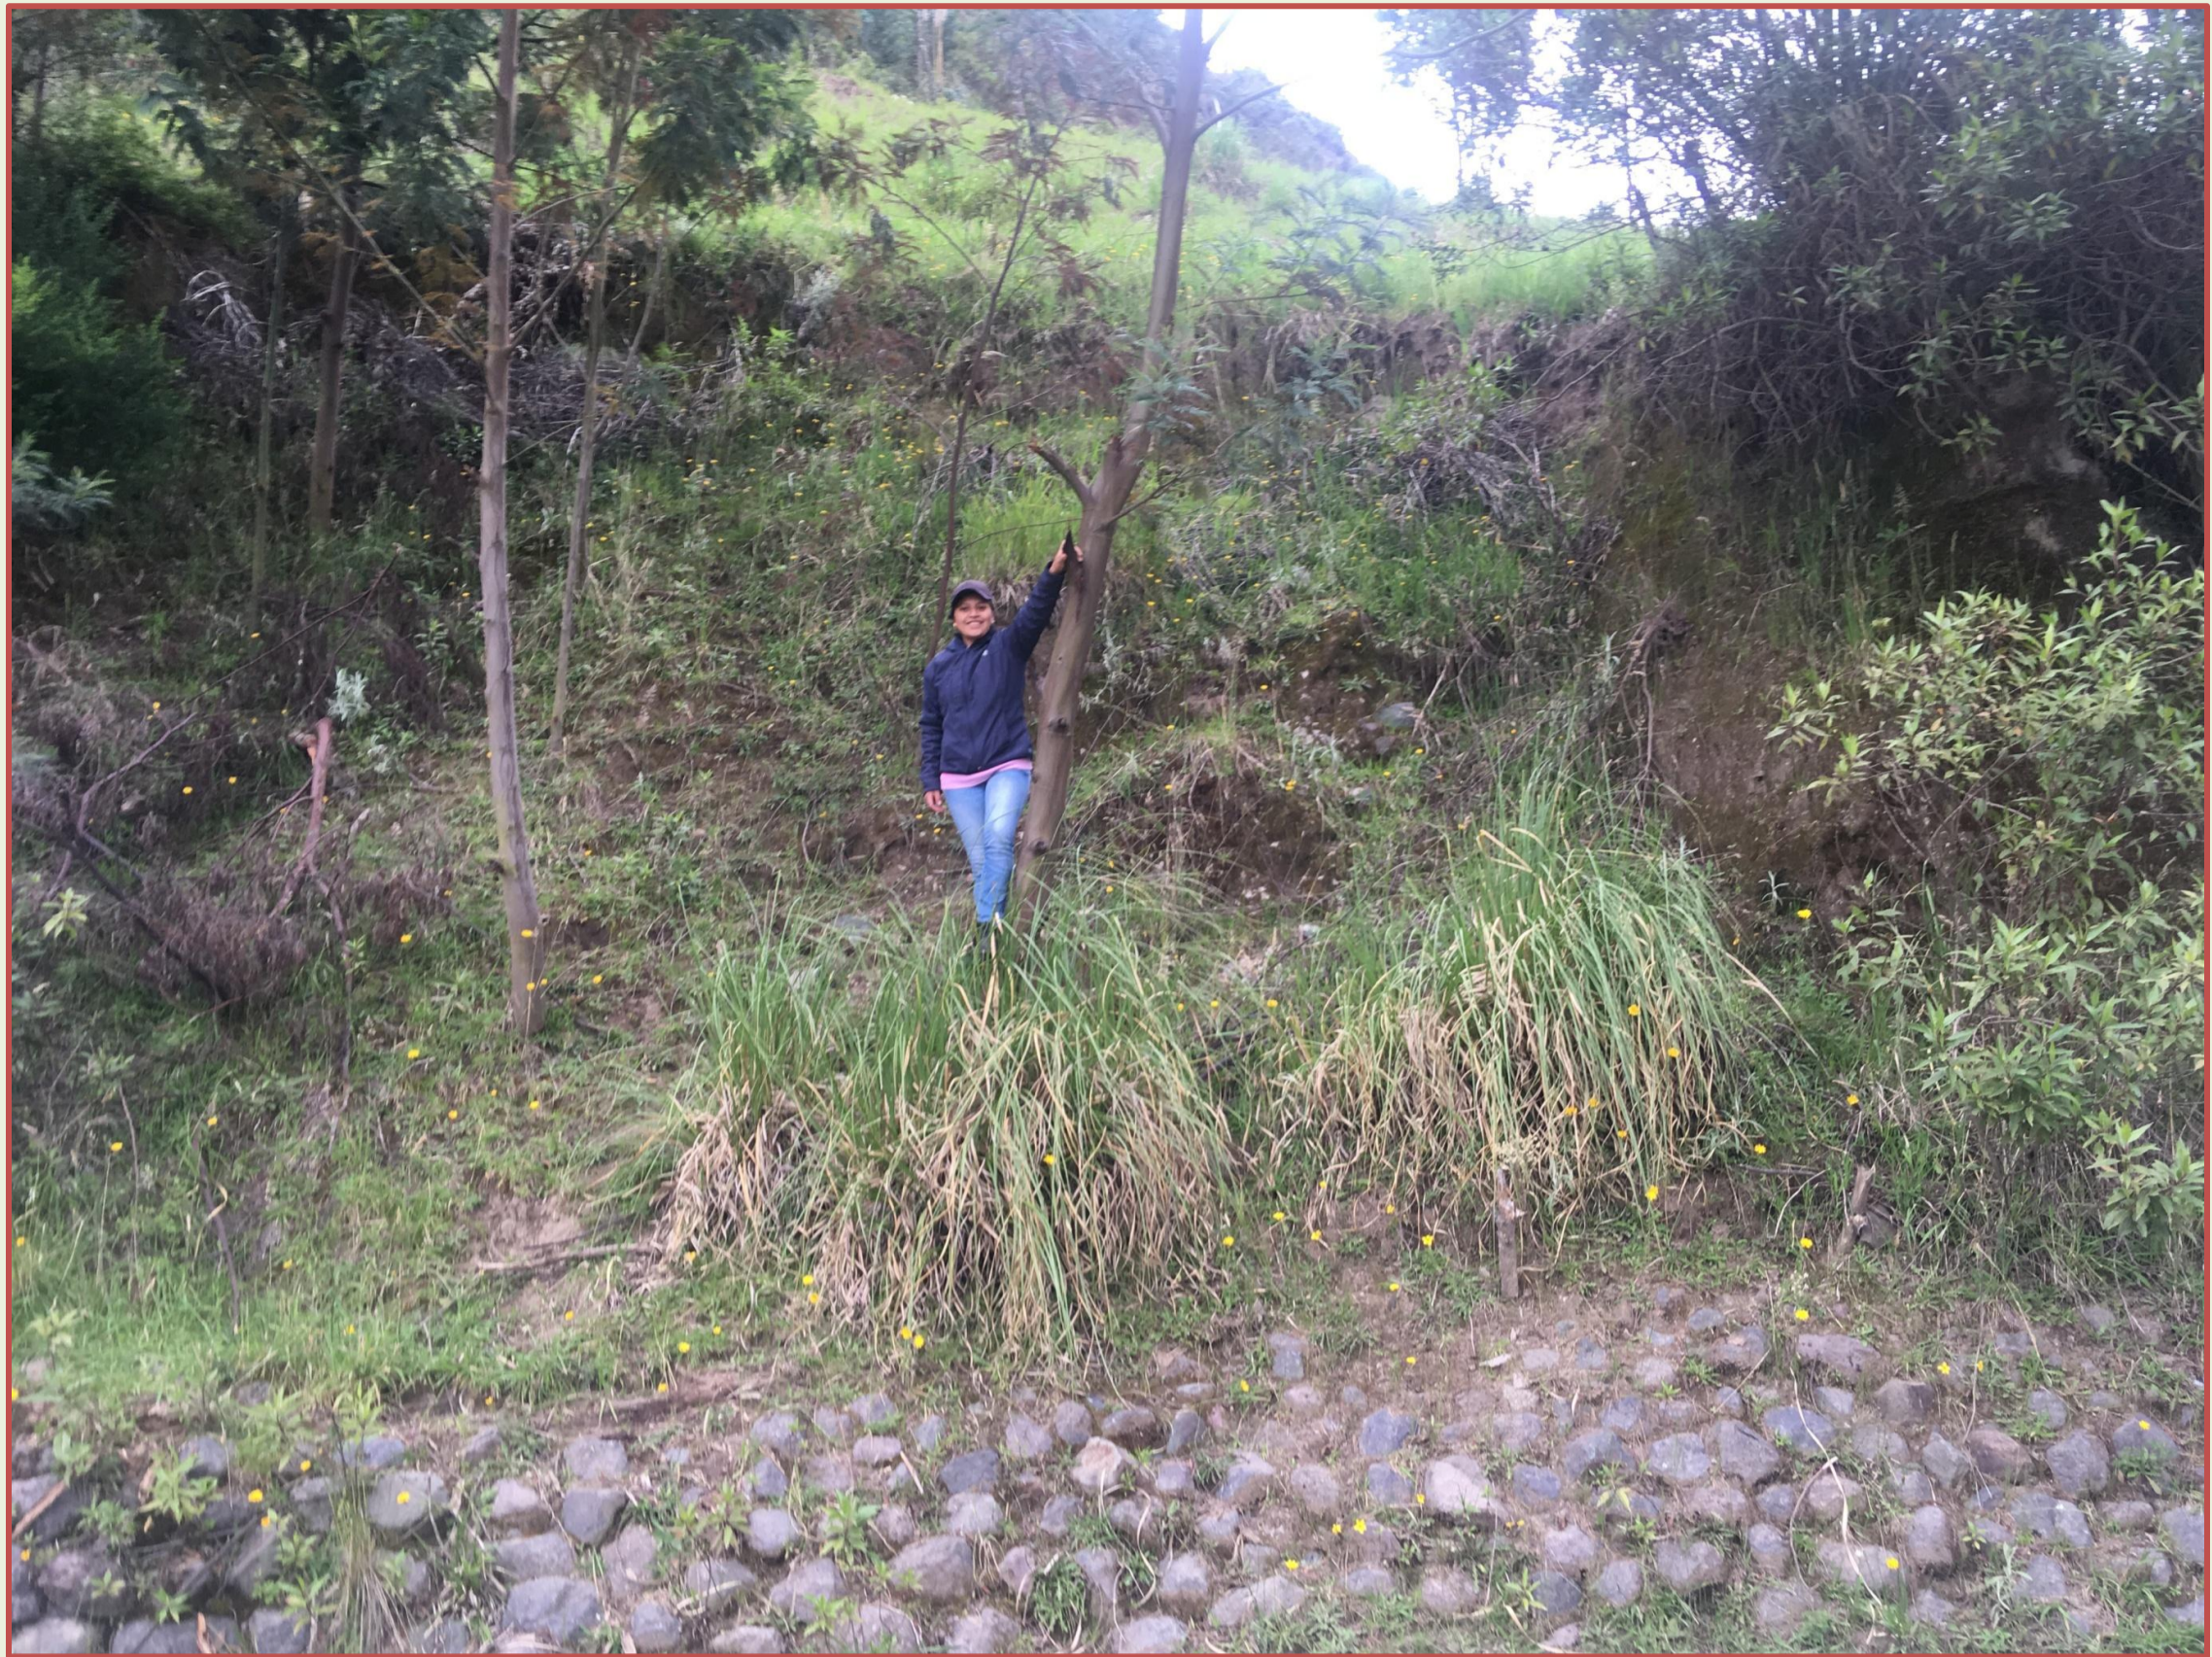
2017 - Chimbusig road cut, 4.5 years post-project, Enma Sacatoro in center of site. The slope now is stabilized by acacia trees over 5 m. tall, vigorous sigsig hedges, boulder toe wall, and many volunteer species.

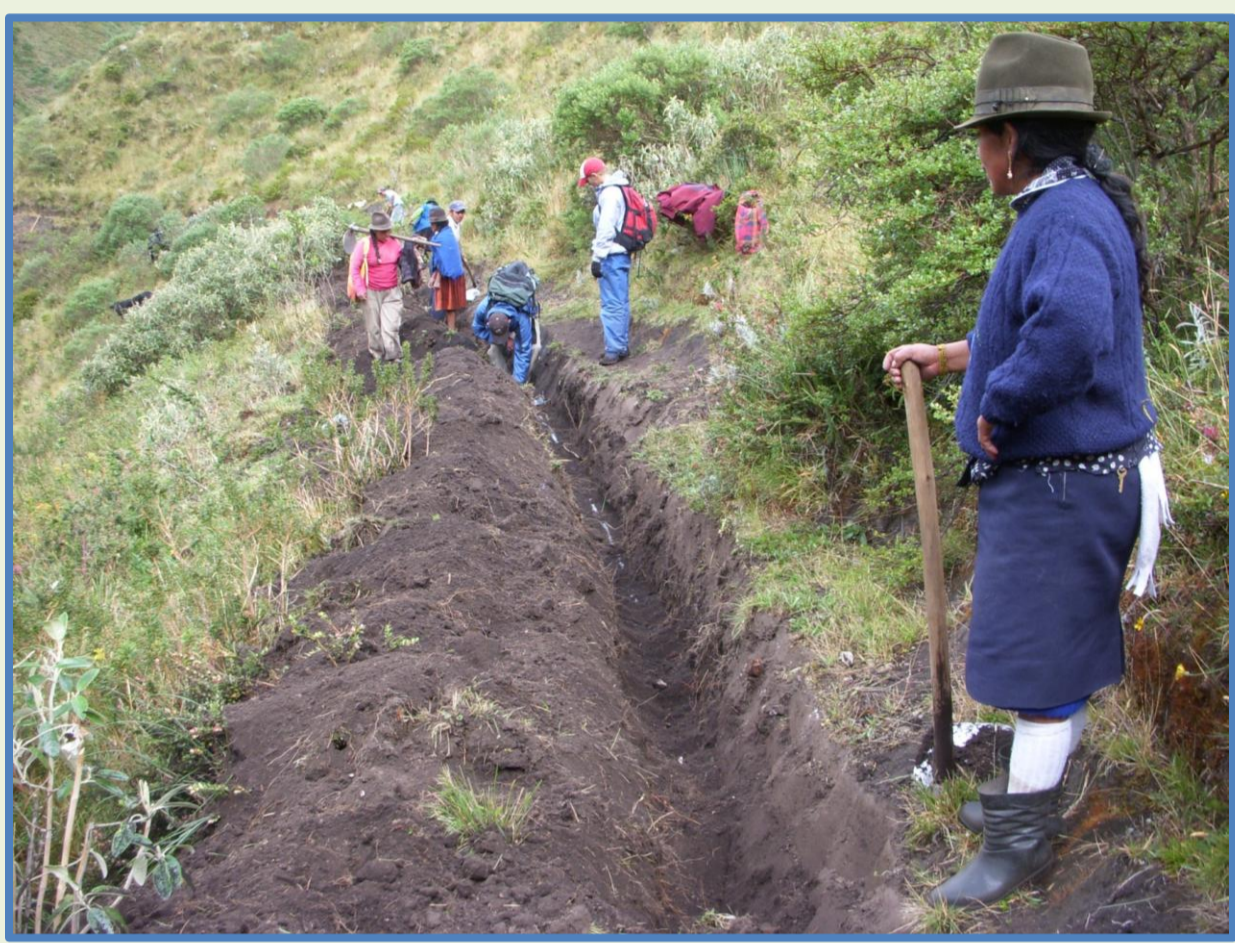
2009, irrigation line from source springs. The minga was digging an improved pipeline through remnant cloud forest “tierra negra” organic soils.

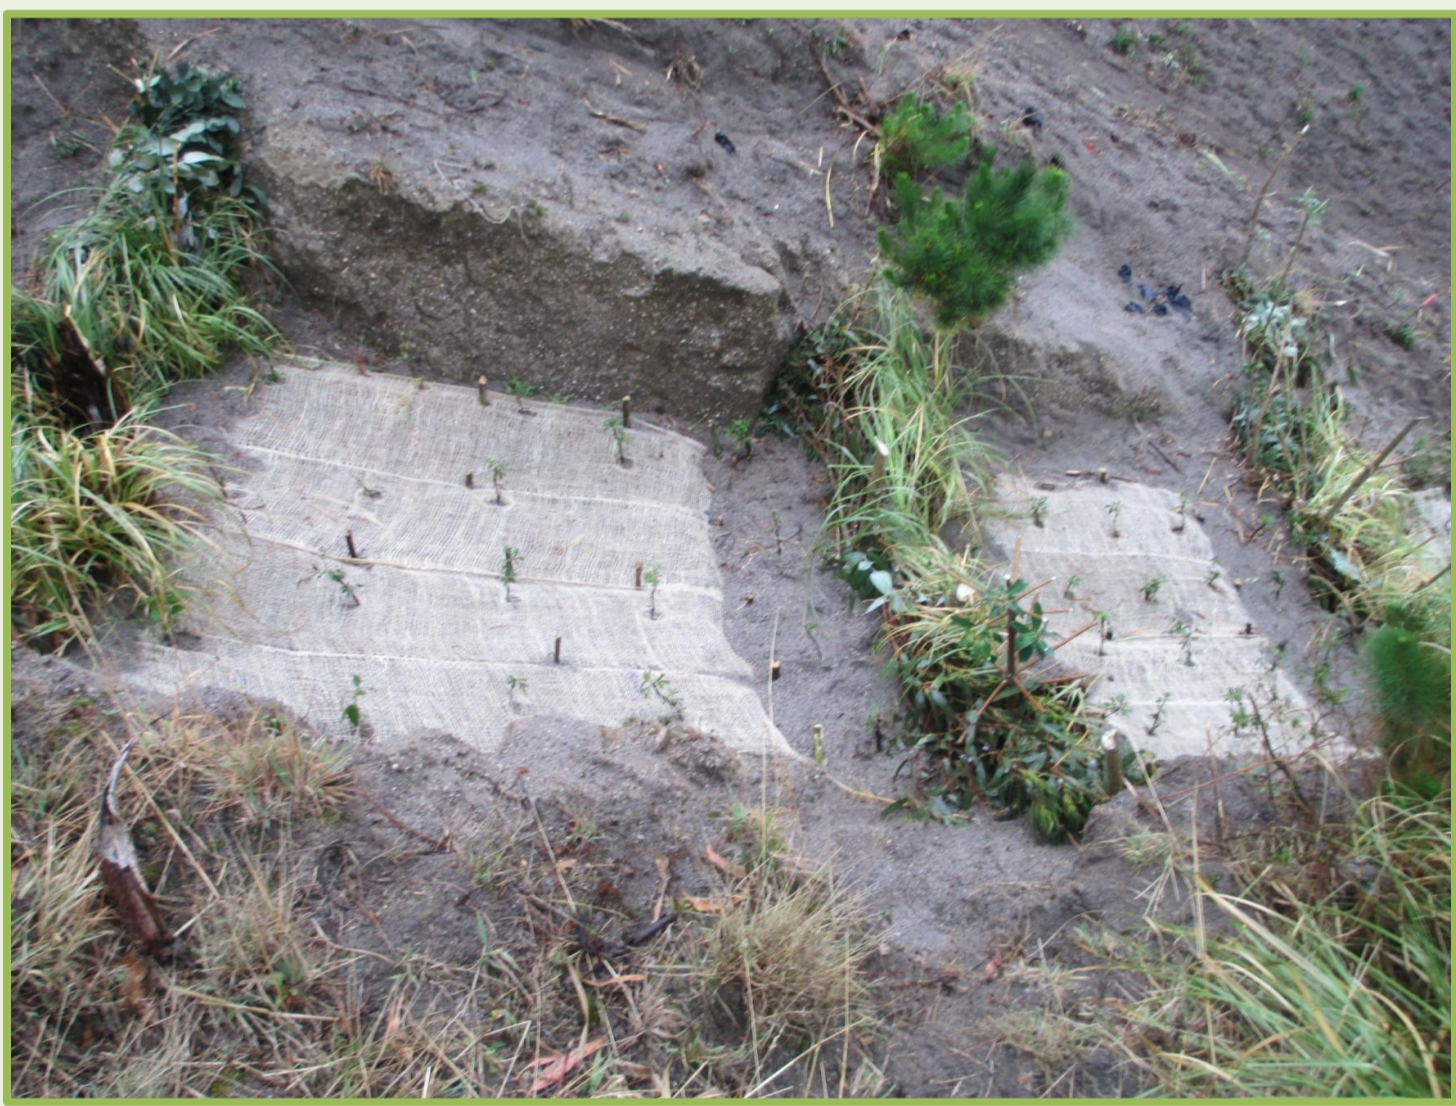
2013 - Erosion gully below pipeline, post-project. Live-stake wicker weirs with sigsig infiltration hedges, local mats, and native plantings stabilized downcutting. Note “tierra blanca” subsoils at the surface.

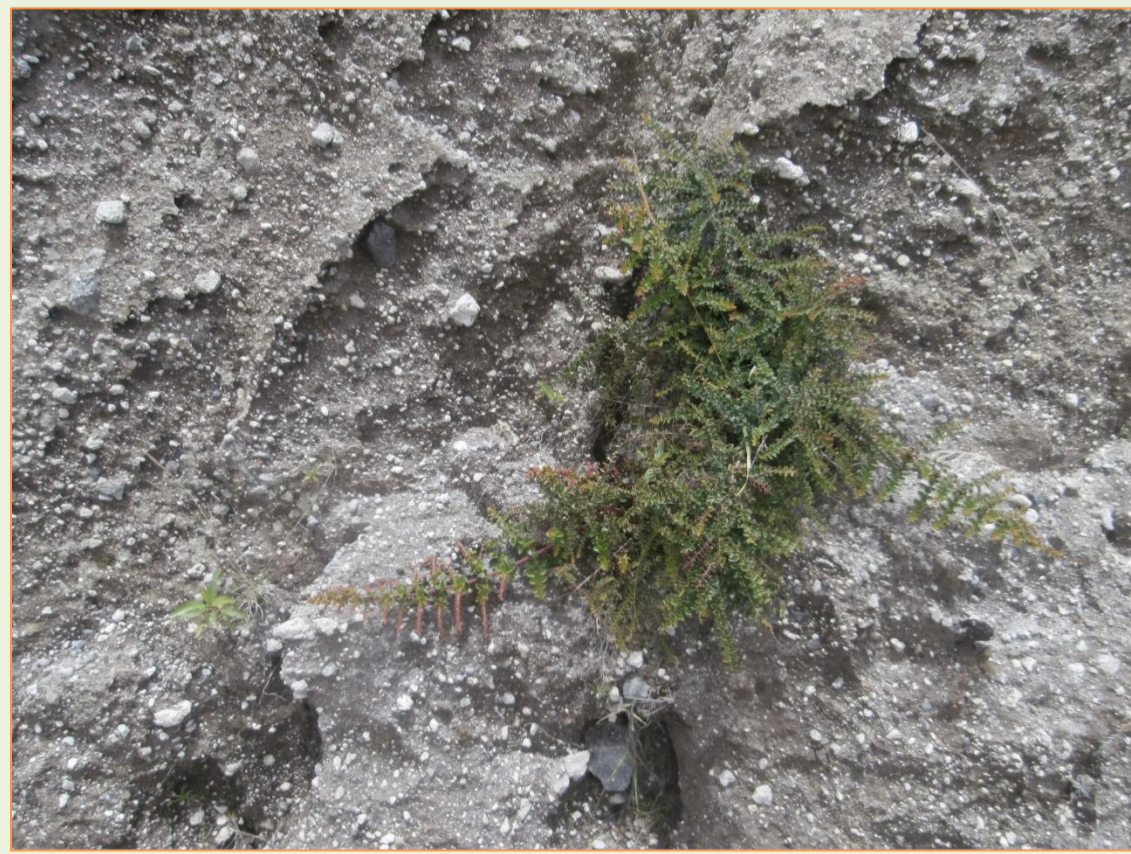
Tashima (*Coriaria ruscifolia*) – could this become a pioneer restoration species on “tierra blanca” slopes?
